QUALITY INSPECTION TEST REPORT

EXTERIOR TERRAZZO: 600x600x20mm

INDEPENDENT FACTORY TESTING

STANDARD SLAB: 2440x1220x30mm

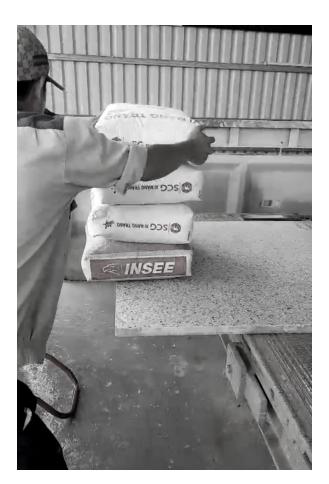
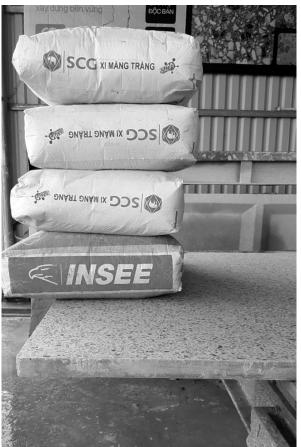
DESCRIPTION	LENGTH (cm)	WEIGHT (kg)	DURATION (min)
BREAKING POINT			
(Weight applied to 40cm unspported overhang)	40	170	60

Slab supported 170kg cement bags at 40cm with no signs of cracking after 60 minutes.
